The Davis Bottom History Preservation Project

The Shotgun House

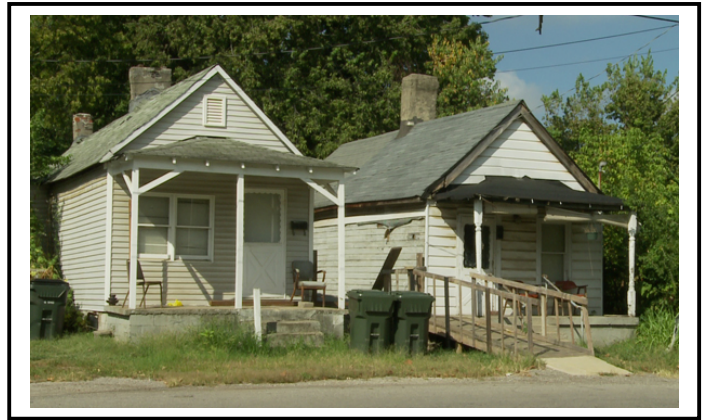
Figure 1: Shotgun houses at 710 (left) and 712 (right) on DeRoode Street, Davis Bottom. Courtesy, Kentucky Archaeological Survey, 2010.

Many of the residential homes built in Davis Bottom were an architectural style commonly known as the "shotgun" house. This single-story, wood-frame home was built throughout the Southern United States from the 1860s to the 1920s. Shotgun homes are inexpensive, rectangular structures designed to fit narrow lots on urban streets. The two shotgun houses at 710 and 712 DeRoode Street (photo right) are the focus of the archaeology, architectural surveys and 2D graphics featured in The Davis Bottom History Preservation Project.

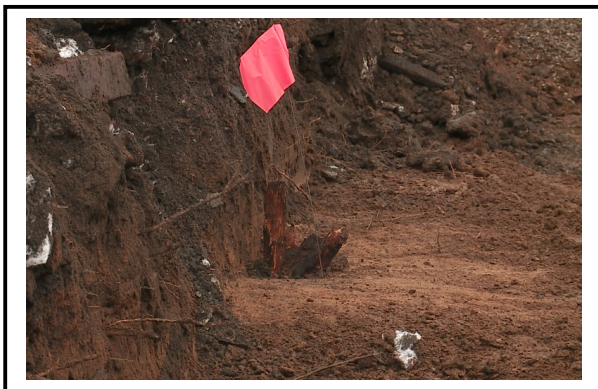
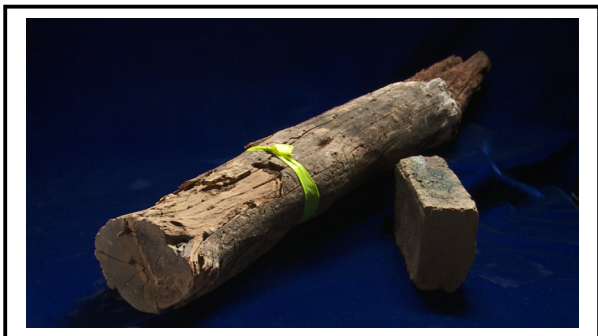
Dr. Tanya Faberson, Principal Archaeologist, Cultural Resources Analysts, conducted extensive investigations of the shotgun homes at 710 and 712 DeRoode (see *Archaeology* pages on this website). During excavations, her team discovered post molds and the remnants of wood-post piers. “All of the shotgun houses, or the remains of the shotgun houses, had been build up on these wood post foundation piers,” says Faberson. “And what that tells us is that these particular buildings were probably lifted up off the ground, which makes sense in an area that is frequently flooded,” Faberson adds. Flooding was a major problem for lower sections of Davis Bottom. Wood post piers (many later reinforced with stone) were not only used for flood-control, but they were also much cheaper than limestone or brick foundations.

Figures 5 & 6: A wood post pier (top) in situ at 712 DeRoode Street, and (bottom) at the archaeology laboratory with a brick for scale. Courtesy, Cultural Resource Analysts, Inc. and The Kentucky Archaeological Survey, 2011

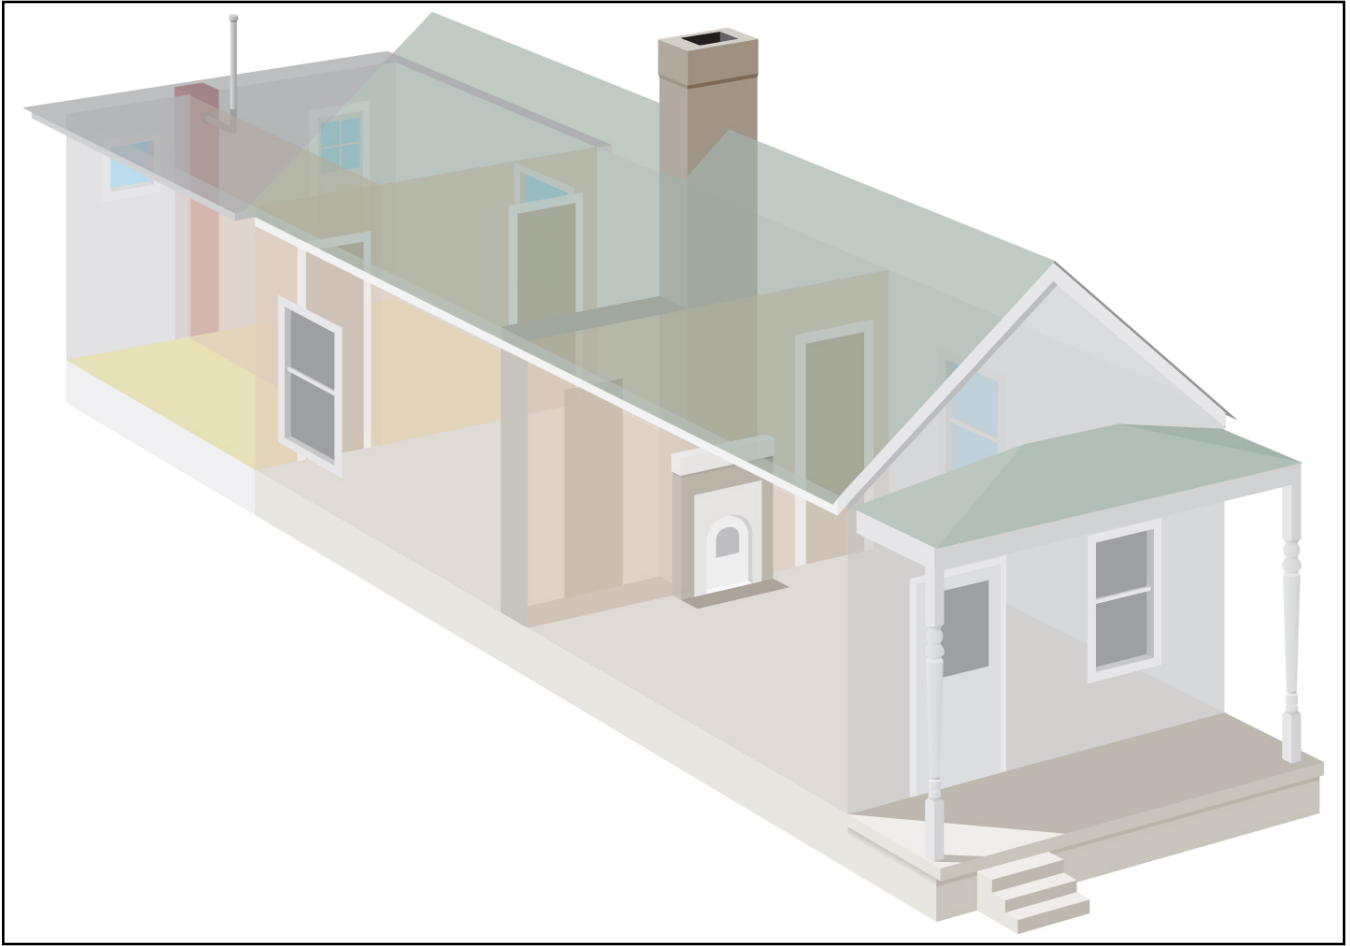
Figure 9: A 2D graphic of the shotgun house at 712 DeRoode based on field surveys conducted by scholars with the Kentucky Transportation Cabinet. Courtesy, The Kentucky Archaeological Survey, 2012
